Inspector: Rachel Koehler

Inspection Date: 1/26/2007

Building: Apollo High School **Location:** Storage Room A325 **Type of Space:** Tunnel

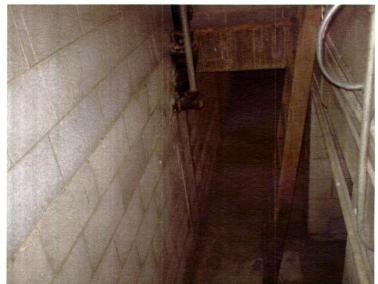
Space Classification: Non-Permit

Potential Hazards:
No Hazards

Comments: Tunnel travels the perimeter of the gymnasium.

Photo Description
Tunnel access in Storage
Room A325.

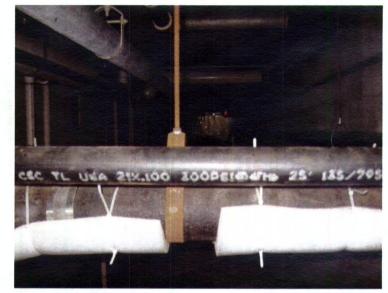
Space Classification: Non-Permit

Potential Hazards:No Hazards

Comments: Tunnel travels around pool.

Photo Description
Tunnel access off Pool
Office.

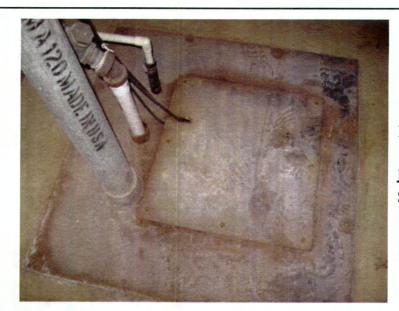
Sump

Space Classification: Permit

Potential Hazards:

Potential for oxygen deficiency

Engulfment

Comments: Lockout/Tagout procedures for pumps are required

prior to entry.

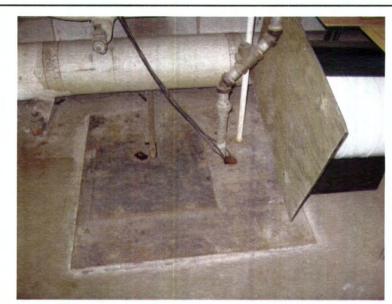
Type of Space: Sump (3)
Space Classification: Permit

Potential Hazards:

Potential for oxygen deficiency

Engulfment

Comments: Lockout/Tagout procedures for pumps are required

prior to entry.

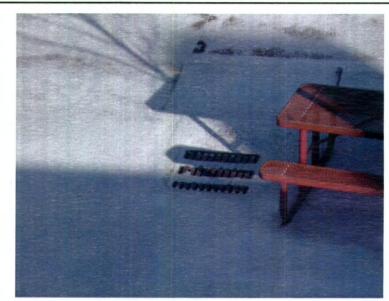
Storm Sewer

Type of Space: Storm sewer Space Classification: Permit

Potential Hazards:

Potential for oxygen deficiency

Engulfment Configuration

City sewer or water Fall hazards Poor lighting Slick/wet surfaces

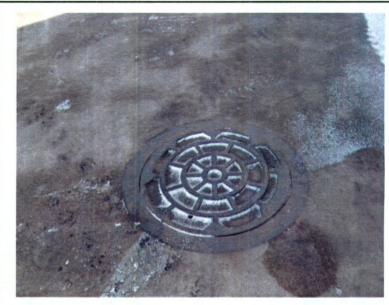
Type of Space: Manhole (2) Space Classification: Permit

Potential Hazards:

Potential for oxygen deficiency

Engulfment Configuration

City sewer or water Fall hazards Poor lighting Slick/wet surfaces

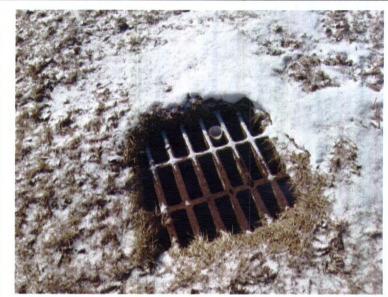
Location: Exterior Building East side Type of Space: Storm sewer (2) Space Classification: Permit

Potential Hazards:

Potential for oxygen deficiency

Engulfment Configuration

City sewer or water Fall hazards Poor lighting Slick/wet surfaces

Photo Description
Storm Sewer

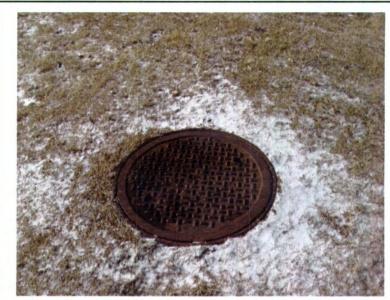
Type of Space: Manhole Space Classification: Permit

Potential Hazards:

Potential for oxygen deficiency

Engulfment Configuration

City sewer or water Fall hazards Poor lighting Slick/wet surfaces

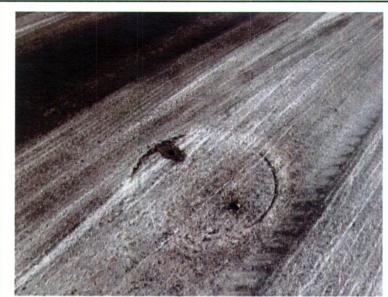
Type of Space: Manhole (2) Space Classification: Permit

Potential Hazards:

Potential for oxygen deficiency

Engulfment Configuration

City sewer or water Fall hazards Poor lighting Slick/wet surfaces

Photo Description
Manhole
