Inspector: Rachel Koehler

**Inspection Date:** 12/1/2006

**Building:** Clearview Elementary **Location:** Exterior Building by Door 5

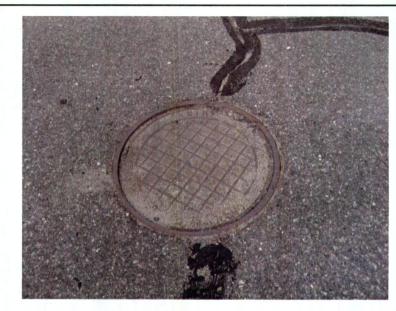
Type of Space: Manhole Space Classification: Permit

**Potential Hazards:**

Potential for oxygen deficiency

Engulfment Configuration

City sewer or water Fall hazards Poor lighting Slick/wet surfaces Comments: None

**Photo Description**Manhole

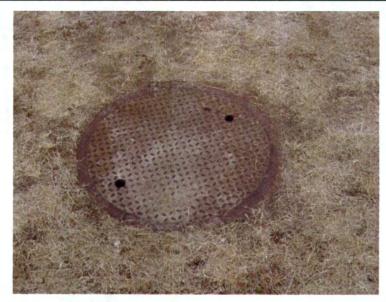
Type of Space: Manhole Space Classification: Permit

**Potential Hazards:**

Potential for oxygen deficiency

Engulfment Configuration

City sewer or water Fall hazards Poor lighting Slick/wet surfaces Comments: None

**Photo Description**Manhole

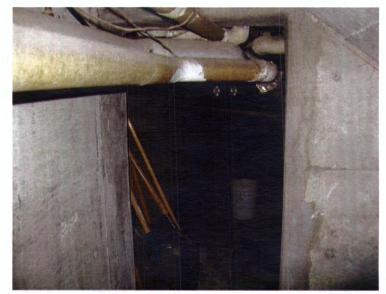
Space Classification: Non-Permit

Potential Hazards:
No Hazards

Asbestos

City sewer or water

Gas lines Poor lighting Steam pipes

Comments: Tunnel runs along the east side of the building.

**Photo Description**Tunnel access in Boiler Room.

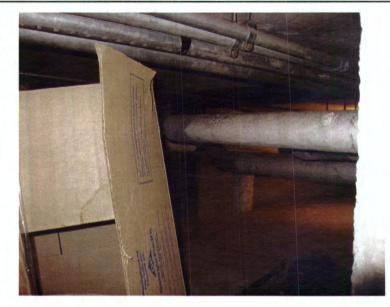
Space Classification: Non-Permit

Potential Hazards: No Hazards

Asbestos

City sewer or water

Electrical
Gas lines
Poor lighting
Steam pipes

Comments: Tunnel runs along the south side of the building.

Photo Description
Tunnel access in Boiler
Room.

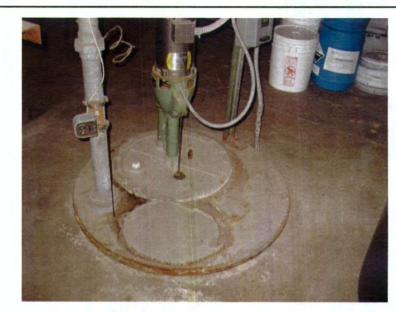
Space Classification: Permit

**Potential Hazards:**

Potential for oxygen deficiency

Engulfment

Biological

City sewer or water Slick/wet surfaces

Sump

Comments: Lockout/Tagout procedures for pumps are required

prior to entry.

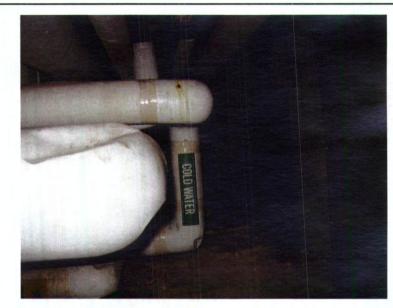
Space Classification: Non-Permit

Potential Hazards:
No Hazards

Asbestos

City sewer or water

Electrical
Gas lines
Poor lighting
Steam pipes

Comments: Tunnels runs along the west side of the building.

Photo Description
Tunnel access in Boiler
Room.
