Building: McKinley Center **Location:** Mechanical Room G21

Type of Space: Tunnel

Space Classification: Non-Permit

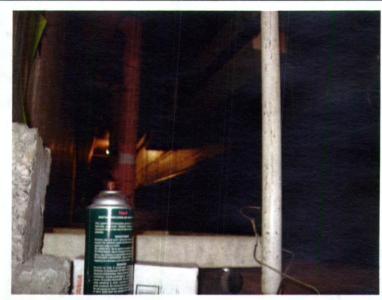
Asbestos

Electrical Poor lighting Steam pipes

Comments: Tunnel travels throughout south side of building.

Photo Description
Tunnel access from
Mechanical Room G21.

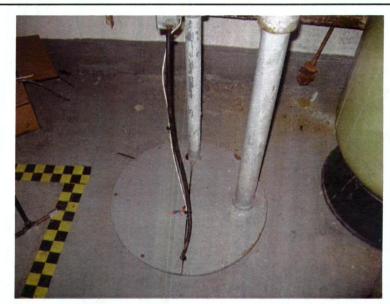
Potential for oxygen deficiency

Engulfment

Biological

Slick/wet surfaces

Sump

Comments: Lockout/Tagout procedures for pumps are required

prior to entry.

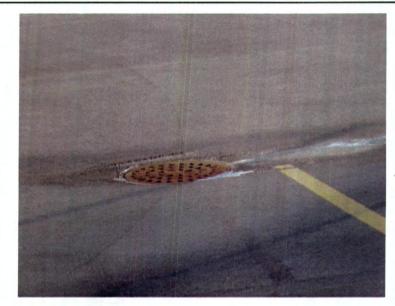
Potential for oxygen deficiency

Engulfment Configuration

City sewer or water Fall hazards Poor lighting Slick/wet surfaces

Photo Description
Storm Sewer

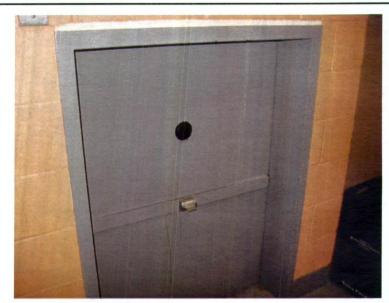
Electrical
Fall hazards
Falling objects

Elevator

Comments: Lockout/Tagout procedures for elevator are

required prior to entry.
