Confined Space Inventory for Saint Cloud Public Schools

Inspector: Rachel Koehler

Inspection Date: 1/22/2007

Building: North Junior High

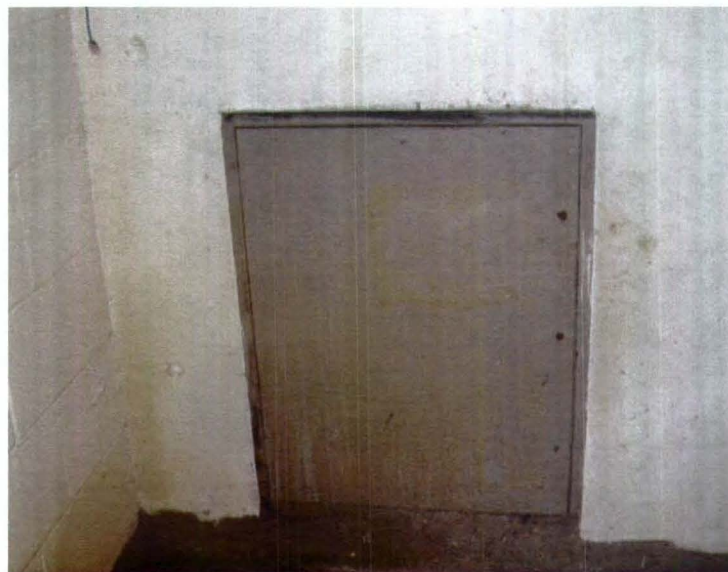
Location: Boiler Room

Type of Space: Tunnel

Space Classification: Non-Permit

Asbestos

City sewer or water

Electrical

Poor lighting

Comments: Tunnel travels around pool.

Tunnel access in Boiler Room.

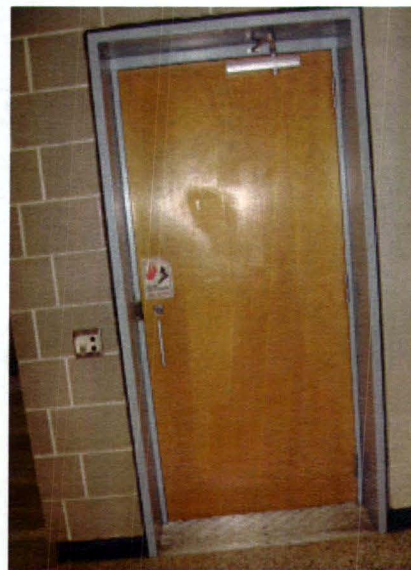
Location: Music/Pool Elevator

Type of Space: Elevator shaft

Space Classification: Non-Permit

Electrical

Fall hazards

Falling objects

Elevator

Comments: Lockout/Tagout procedures for elevator are required prior to entry.

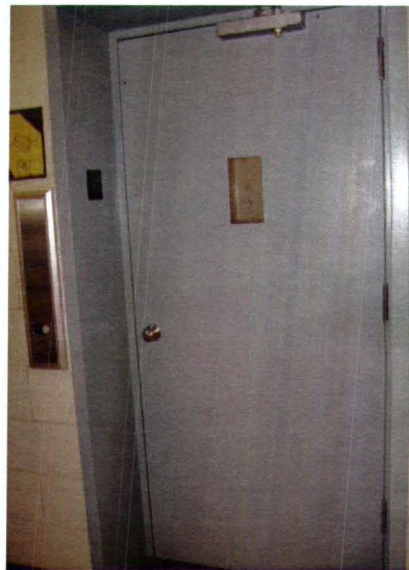
Location: Academics Elevator

Type of Space: Elevator shaft

Space Classification: Non-Permit

Electrical

Fall hazards

Falling objects

Elevator

Comments: Lockout/Tagout procedures for elevator are required prior to entry.
