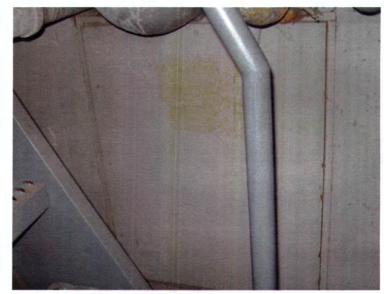
Building: South Junior High **Location:** Boiler Room **Type of Space:** Tunnel

Asbestos

Electrical Poor lighting Steam pipes

Comments: Tunnel travels throughout building.

Photo Description
Tunnel access in Boiler
Room.

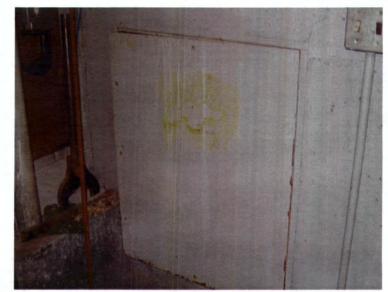
Building: South Junior High **Location:** Boiler Room **Type of Space:** Tunnel

Poor lighting

Comments: Tunnel travels around pool.

Photo Description
Tunnel access in Boiler
Room.

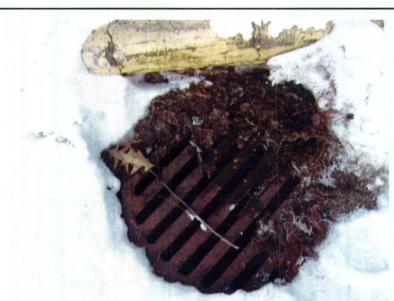
Location: Exterior Building West Parking Lot

Type of Space: Storm sewer (2) Space Classification: Permit

Potential for oxygen deficiency

Engulfment Configuration

City sewer or water Fall hazards Poor lighting Slick/wet surfaces

Storm Sewer

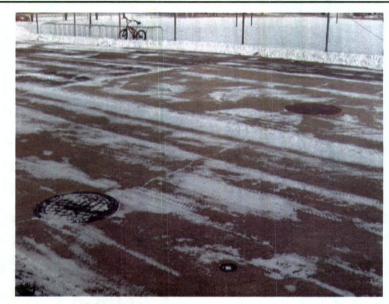
Location: Exterior Building East side

Type of Space: Fuel oil tank Space Classification: Permit

Flammable in excess of its LFL Potential for oxygen deficiency

Engulfment Configuration

Poor lighting Slick/wet surfaces

Photo DescriptionFuel Oil Tank

Comments: Tank must be emptied prior to entry.
