Inspector: Rachel Koehler

Inspection Date: 12/5/2006

Building: Talahi Elementary **Location:** Boiler Room **Type of Space:** Boiler #1

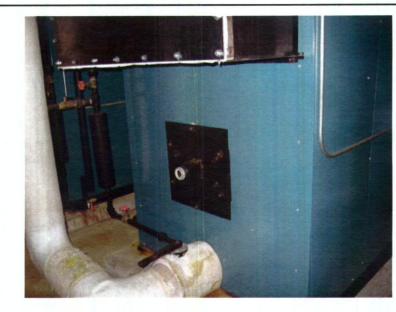
Boiler #1

Space Classification: Non-Permit

Potential Hazards: No Hazards

Electrical
Gas lines
Temperature extremes

Comments: Lockout/Tagout procedures for boiler are required

prior to entry.

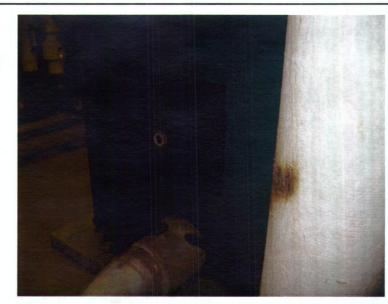
Photo Description
Boiler #2

Space Classification: Non-Permit

Potential Hazards:No Hazards

Electrical Gas lines

Temperature extremes

Comments: Lockout/Tagout procedures for boiler are required

prior to entry.

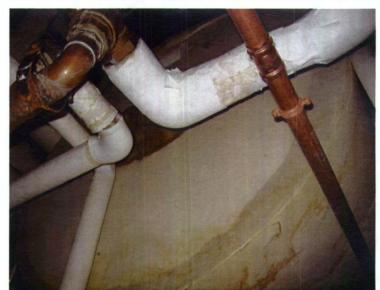
Water Tank

Building: Talahi Elementary **Location:** Boiler Room **Type of Space:** Water tank **Space Classification:** Permit

Potential for oxygen deficiency

Engulfment Configuration

Other Considerations: City sewer or water

Poor lighting Slick/wet surfaces

Comments: Tank must be emptied, and all supply lines must be

locked out and tagged out prior to entry.

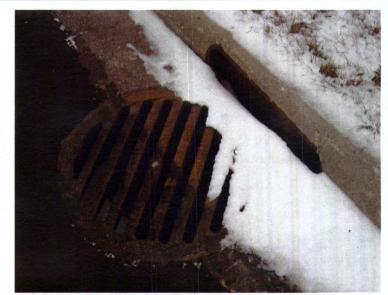
Photo DescriptionStorm Sewer

Type of Space: Storm sewer Space Classification: Permit

Potential for oxygen deficiency

Engulfment Configuration

City sewer or water Fall hazards Poor lighting Slick/wet surfaces

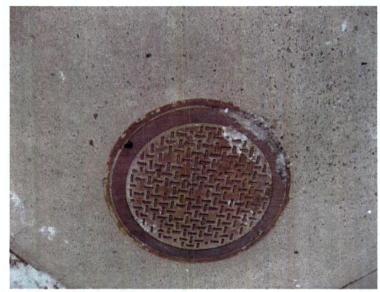
Photo DescriptionManhole

Type of Space: Manhole Space Classification: Permit

Potential for oxygen deficiency

Engulfment Configuration

City sewer or water Fall hazards Poor lighting Slick/wet surfaces

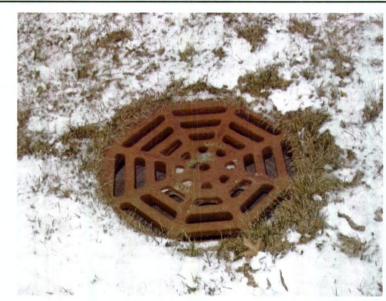
Photo DescriptionStorm Sewer

Location: Exterior Building West side **Type of Space:** Storm sewer (3) **Space Classification:** Permit

Potential for oxygen deficiency

Engulfment Configuration

City sewer or water Fall hazards Poor lighting Slick/wet surfaces
