**Building:** Westwood Elementary

**Location:** Boiler Room **Type of Space:** Tunnel

Space Classification: Non-Permit

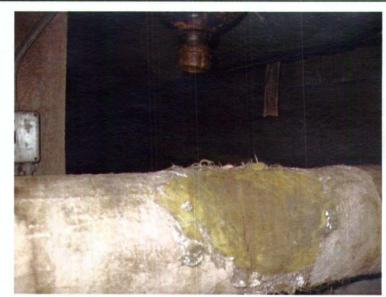
Asbestos

Electrical
Gas lines
Poor lighting
Steam pipes

Comments: Tunnel travels throughout the northeast side of the

building.

Photo Description
Tunnel access in Boiler
Room.

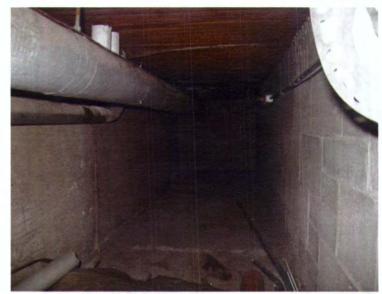
Asbestos

Electrical
Gas lines
Poor lighting
Steam pipes

Comments: Tunnel travels throughout the northwest side of the

building.

Photo Description
Tunnel access in Boiler
Room.

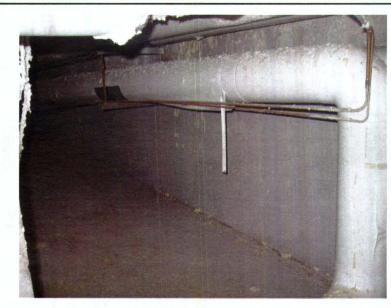
Asbestos

Electrical
Gas lines
Poor lighting
Steam pipes

Comments: Tunnel travels throughout the southeast side of the

building.

Photo Description
Tunnel access in Boiler
Room.

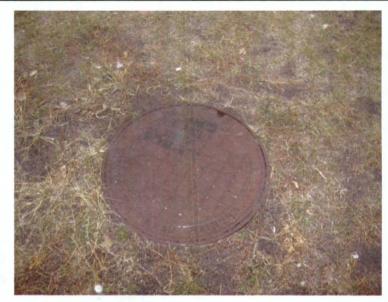
Location: Exterior Building Southwest corner

Type of Space: Storm sewer (2) Space Classification: Permit

Potential for oxygen deficiency

Engulfment Configuration

City sewer or water Fall hazards Poor lighting Slick/wet surfaces

**Photo Description**Storm Sewer

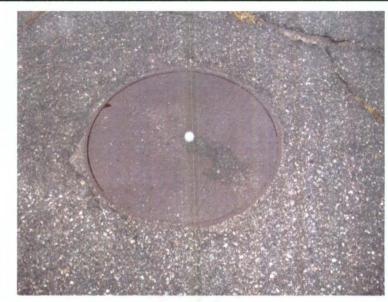
Location: Exterior Building Southeast corner

Type of Space: Storm sewer (2) Space Classification: Permit

Potential for oxygen deficiency

Engulfment Configuration

City sewer or water Fall hazards Poor lighting Slick/wet surfaces

**Photo Description**Storm Sewer
