# Confined Space Inventory for Saint Cloud Public Schools

**Inspection Date:** 11/16/2006

**Building:** *Lincoln Elementary*

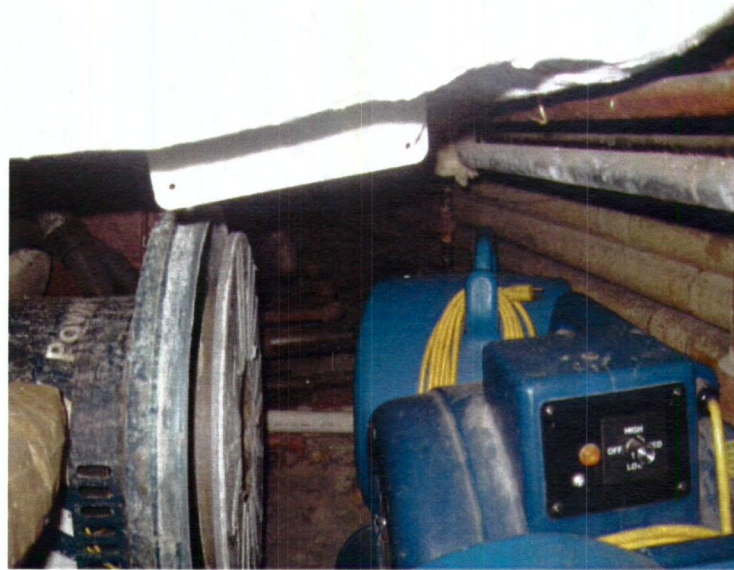
**Location:** *Boiler Room*

**Type of Space:** *Tunnel*

**Space Classification:** *Non-Permit*

*Asbestos*

*City sewer or water*

*Electrical*

*Poor lighting*

*Steam pipes*

**Comments:** *Tunnel travels throughout building except east wing.*

Tunnel access in Boiler Room.

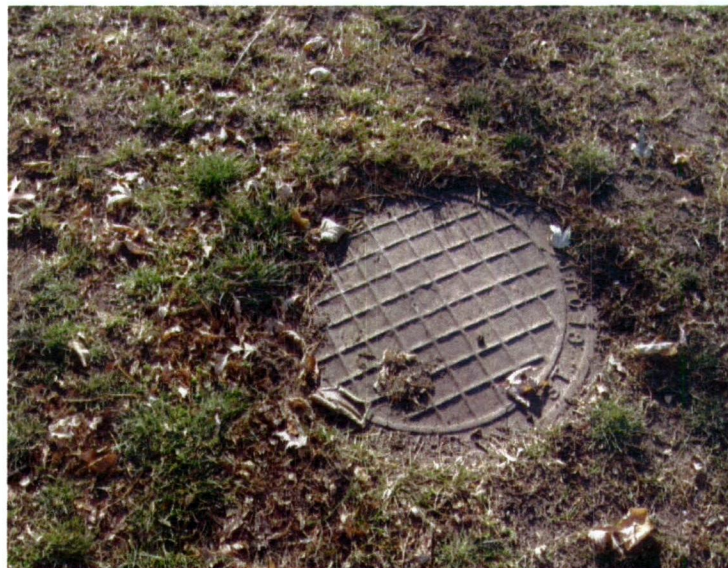
**Location:** *Exterior Building West side*

**Type of Space:** *Storm sewer*

**Space Classification:** *Permit*

*Potential for oxygen deficiency*

*Engulfment*

*Configuration*

*Fall hazards*

*Poor lighting*

*Slick/wet surfaces*

Storm Sewer

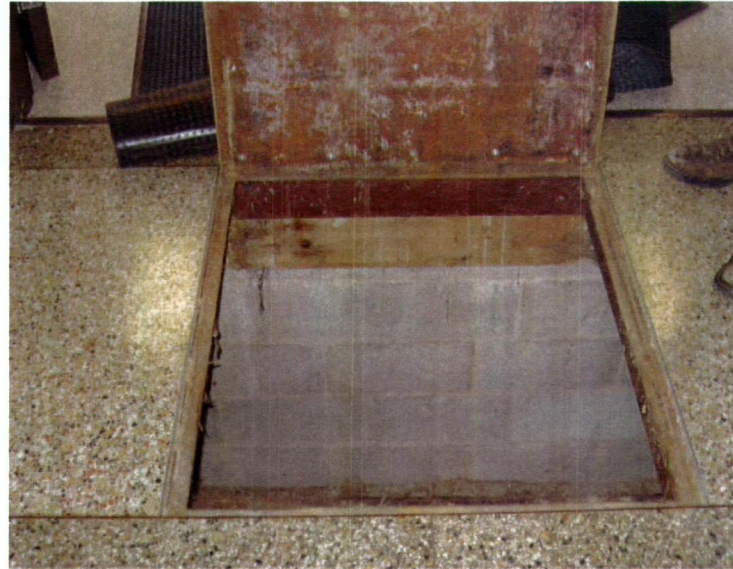
**Location:** *East Entrance*

**Type of Space:** *Tunnel*

**Space Classification:** *Non-Permit*

*Asbestos*

*City sewer or water*

*Electrical*

*Poor lighting*

*Steam pipes*

**Comments:** *Tunnel travels throughout the east wing.*

Tunnel access off east entrance.
