## **Confined Space Inventory for Saint Cloud Public Schools**

**Building:** Madison Elementary

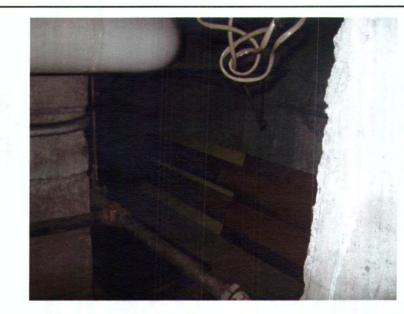
**Location:** Boiler Room **Type of Space:** Tunnel

Space Classification: Non-Permit

Potential Hazards:
No Hazards

Electrical Poor lighting Steam pipes

**Comments:** Tunnel travels throughout building, except the D

wing.

Tunnel access in Boiler Room.

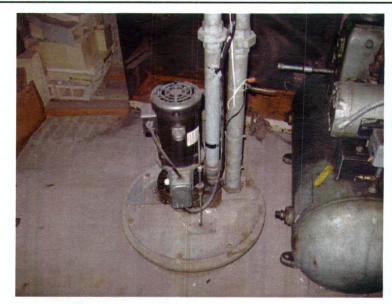
**Building:** Madison Elementary **Location:** A Wing Basement **Type of Space:** Sump

Space Classification: Permit

Potential for oxygen deficiency

Engulfment

City sewer or water Slick/wet surfaces

Sump

Comments: Lockout/Tagout procedures for pumps are required

prior to entry.

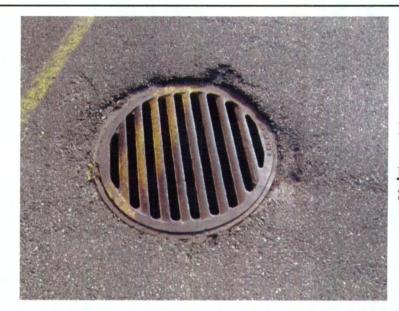
Location: Exterior Building Parking Lot

Type of Space: Storm sewer Space Classification: Permit

Potential for oxygen deficiency

Engulfment Configuration

City sewer or water Fall hazards Poor lighting Slick/wet surfaces

**Photo Description**Storm Sewer
